Colusa Basin Watershed Streambank Analysis

FINAL REPORT

February 25, 2010

Colusa County Resource Conservation District

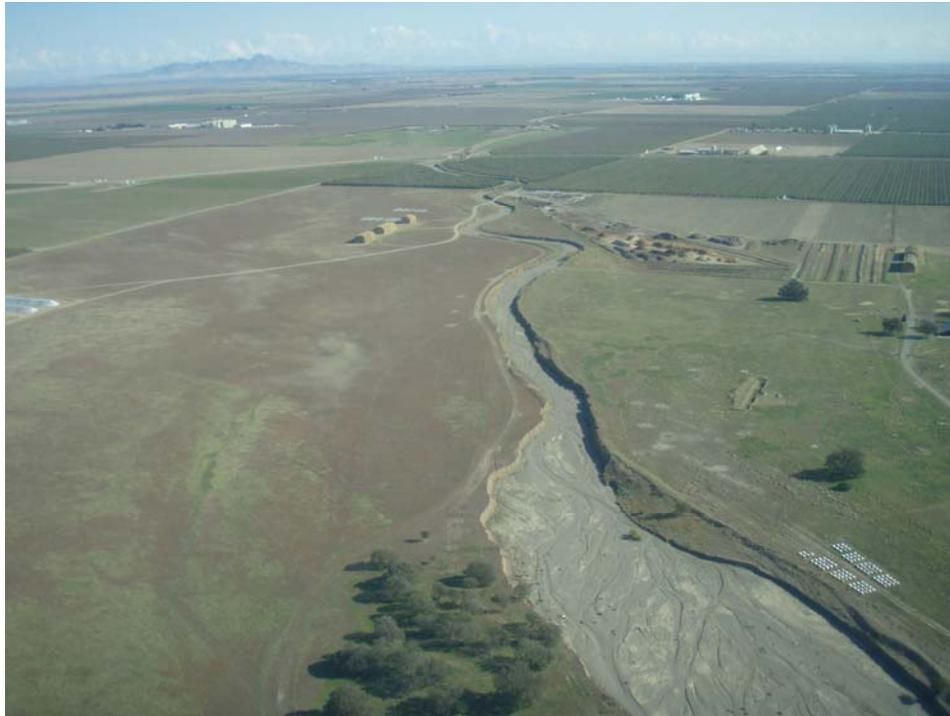
Oblique aerial view to east looking downstream to North Branch Sand Creek approx. 1.3 miles upstream from the Tehama-Colusa Canal. Sutter Buttes in far background. Photo by Kondolf. (November 12, 2009)

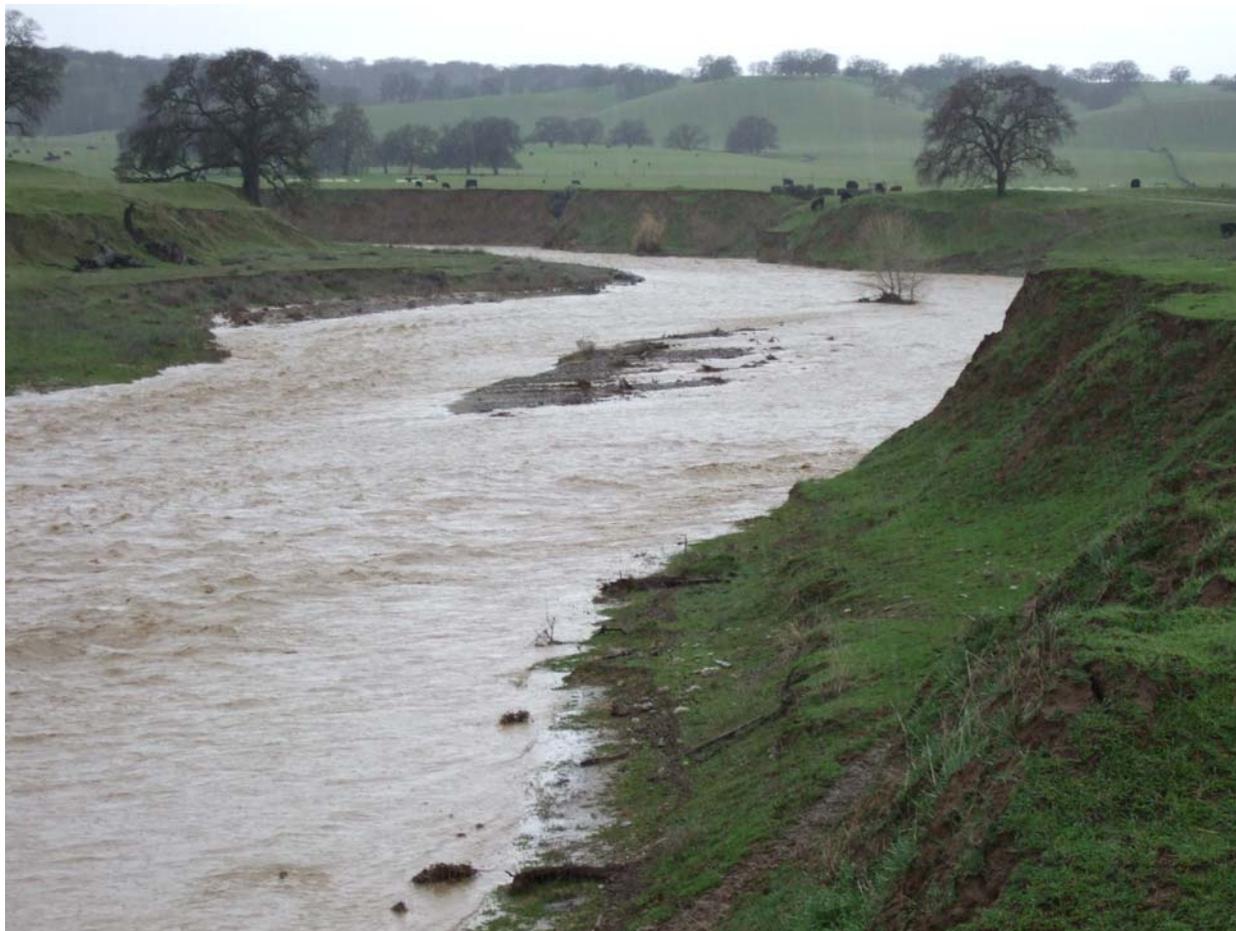
Reference/Critical Management Reach ID: **Reference Reach/CMR 16**

Cortina Creek looking upstream from the top of the left bank to the downstream end of the upland inner valley reach. The left bank just out of view in the middle ground are Upper Modesto Formation deposits actively retreating by bank erosion, allowing the formation of the mid-channel bar colonized by several young cottonwoods. Grazing and groundwater availability may reduce successful establishment of cottonwood in the reach. (January 20, 2010).

Recommended Management Objectives: EC, HC, IC

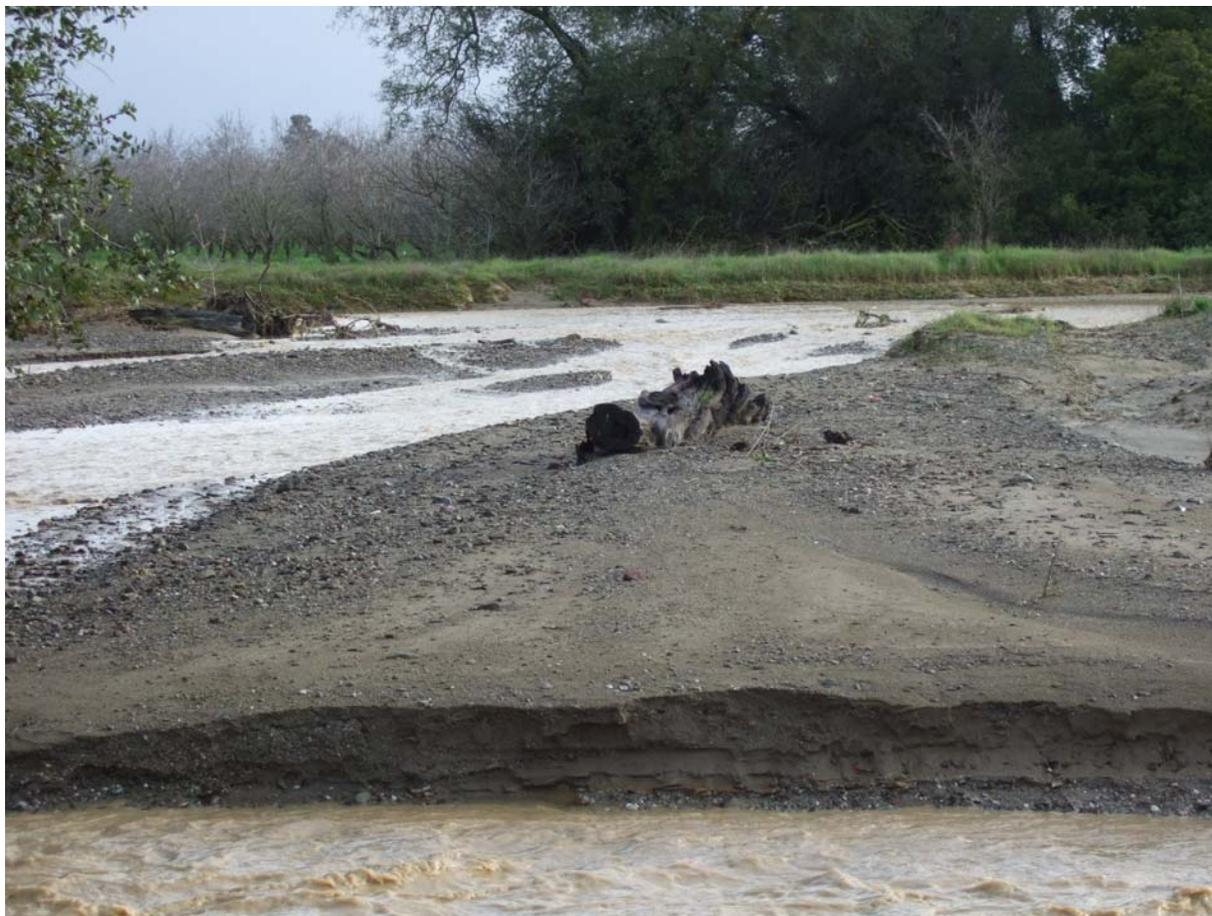
Reference/Critical Management Reach ID: Reference Reach/CMR 17

Elk Creek looking south upstream to the right bank in a locally braided reach from the channel bed approx. 300 ft downstream from the North Fork Elk Creek tributary confluence. (January 20, 2010).

Reach Description: Elk Creek from approx. 1 mile upstream from the North Fork Elk Creek confluence downstream to Elk Creek's confluence with Salt Creek (South) near the Town of Arbuckle. The reach is naturally steep ($S=0.007$) and dynamic and shallowly incised (2-3 ft) in Upper Modesto and Holocene gravelly floodplain deposits of the coalesced Elk Creek and Salt Creek (South) alluvial fans. The reach is almost entirely flanked by orchards on both sides. Portions of the reach have been leveed, straightened, and narrowly confined, without widespread severe bank erosion consequences noted in initial field reconnaissance. There are several separate individual parcels adjoining the creek channel that are not currently in agricultural production. Some of the parcels host variable quality woody riparian habitats. Tributary North Fork Elk Creek hosts perhaps the longest extent of contiguous high quality riparian habitat (oak woodland) among Colusa County streams east of the foothills. The North Fork Elk Creek riparian corridor extends down to where it is tributary to Elk Creek. There is a natural vegetated island bar on Elk Creek at the North Fork Elk Creek confluence, and the reach is wide enough here to be locally braided. Properties are commonly subdivided into 10-acre minimum parcels in this vicinity, such that the Elk Creek Reference Reach contains numerous individual property owners. Its proximity to the Town of Arbuckle provides an opportunity to restore a more contiguous woody riparian corridor that improves wildlife habitat as well as the overall natural integrity of the landscape as an amenity for local residents. See Figure 7 for air photos and mapped resource conditions of this Reference Reach.

Recommended Management Objectives: EC, HC, IC

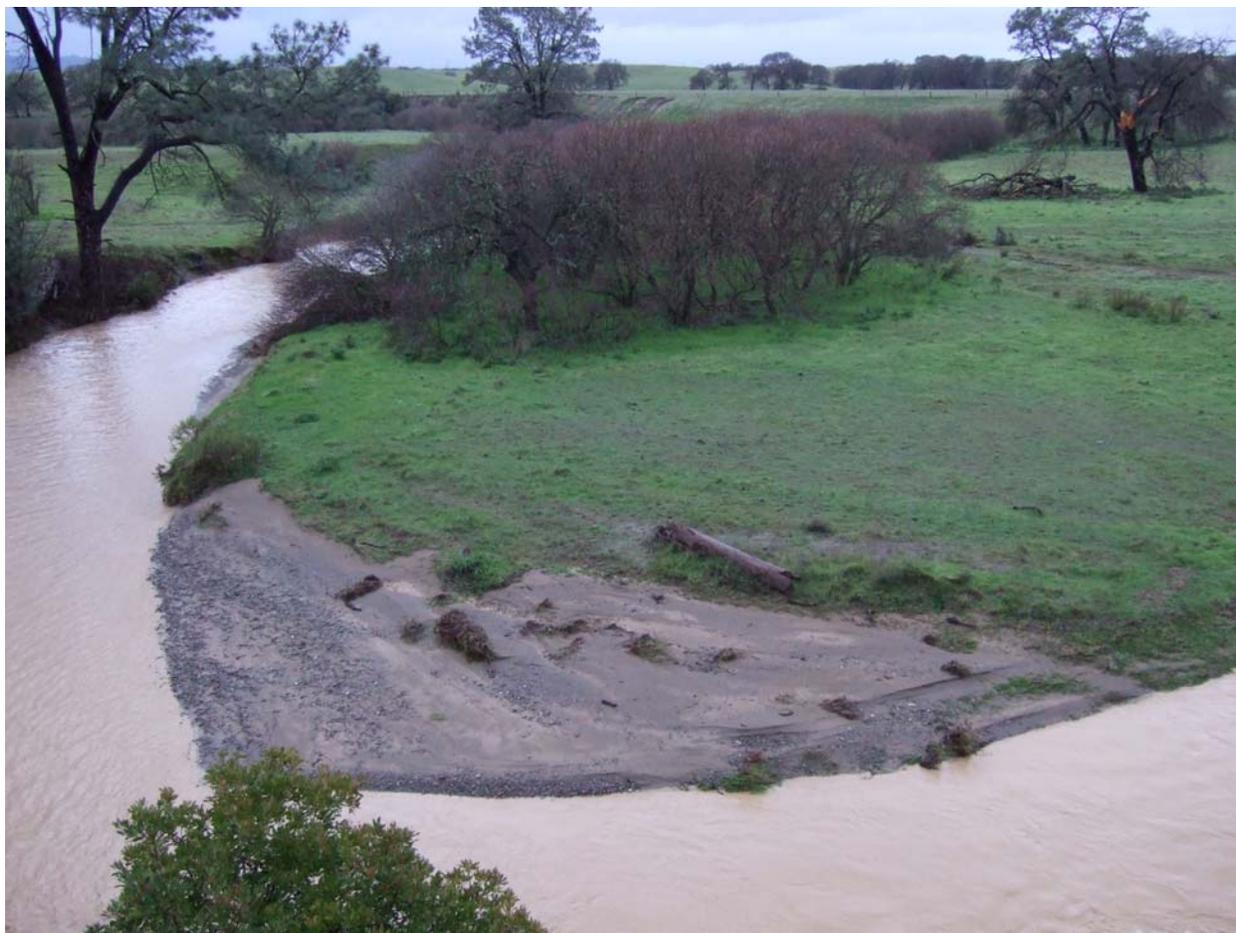
Reference Reach/Critical Management Reach ID: **Reference Reach/CMR 20**

South Fork Buckeye Creek from the top of right bank looking north upstream to meanders cut in Tehama Formation forming the right bank below the view and Red Bluff Formation forming the left bank in the background. The broad floodplain bars overflow during relatively frequent floods and are in places colonized by dense stands of native woody riparian vegetation, such as Buckeye in the middle of the view. (January 20, 2010).

Recommended Management Objectives: EC, HC, IC
